Landscape and Arboricultural Consultant

Report on trees associated with subsidence at 26/28  
Warrington Crescent W9. Mr N Foster & Mr G Ridnell

Report on trees associated with subsidence at  
26 & 28 Warrington Crescent W9.

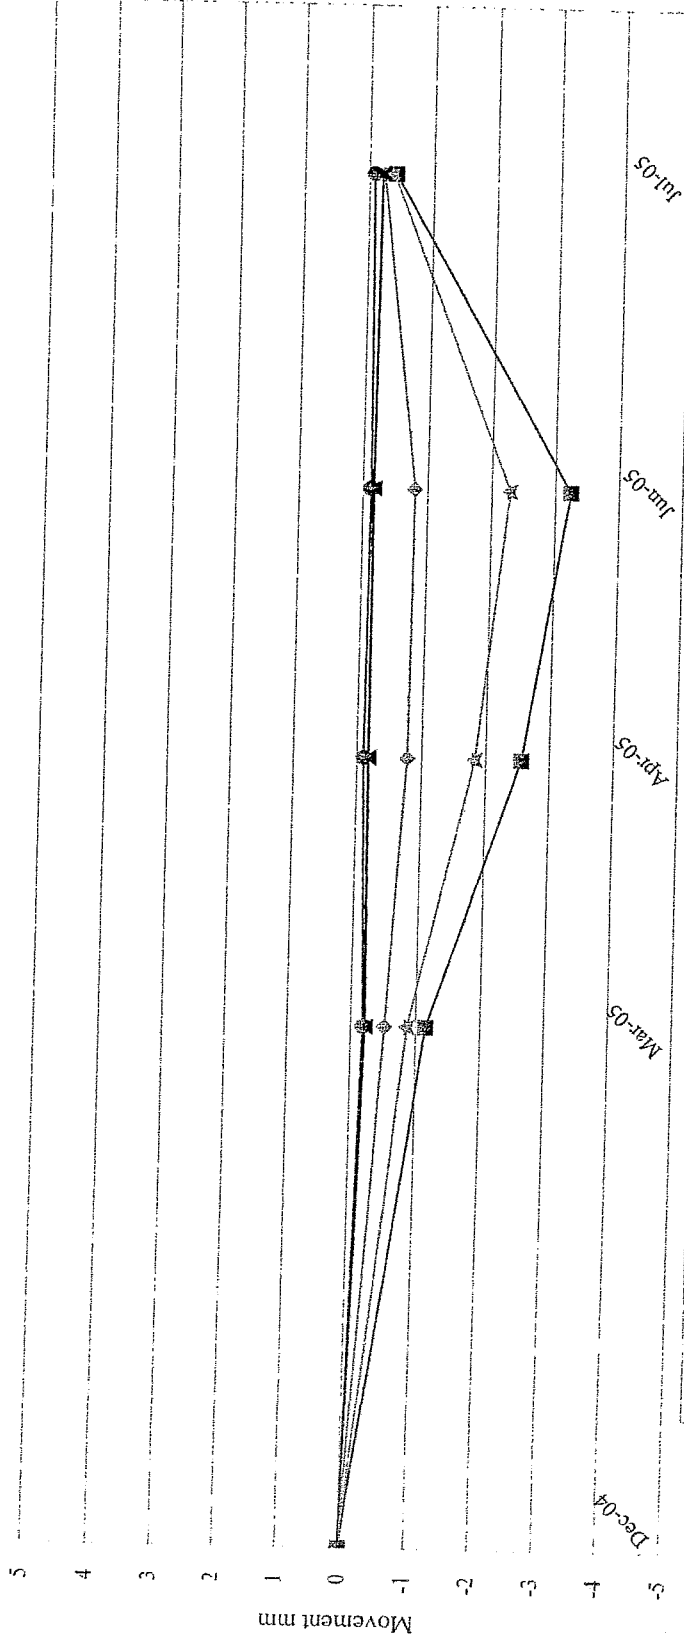
26 Warrington Crescent, London W9.  
 D I Carr Consulting Engineers :- JOB No. 11739 Sheet No D10

4.1 All four crack monitors closed from December 22nd 2004 to June 5th 2005, 1A by a maximum of 3.25mm and 1C by a minimum of 0.17mm. This modest but steady closure has taken place in spite of the exceptionally dry winter and spring.

4.2 The July 24th readings were taken during the peak growing season and show a maximum opening of 2.84mm. The readings to date are entirely consistent with the influence of vegetation.
