**Report on Trees  
at  
Formosa Amenity Garden  
London W9**

**Compiled & presented by  
Simon R. M. Jones, Dip. Arb. (RFS), F. Arbor. A.**

**August 2011**

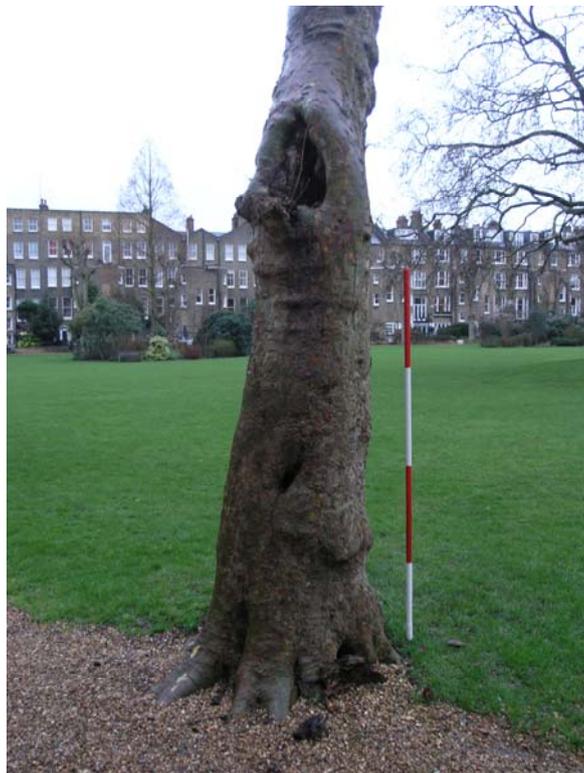
***Photo 1. Tree no. 11***

5.2.3. The climbed inspection undertaken confirmed that four trees contain extensive decay; these are the plane trees nos. 11, 18 and 26 and the Horse chestnut no. 55. It is advisable in the interests of health and safety that these specimens are removed as the existing pollarding regime will not prevent the decay expanding. This decay does not render these trees imminently dangerous; but it is extensive enough that

5.2.4. Tree no. 11 has abnormal swelling at the base of the trunk with a cavity at 1m above ground level which measures 110mm across, 130mm high, has a horizontal extent of 200mm, and a downward extent of 300mm. There is also a large cavity on the east side of the trunk at 2.3m above ground level which measures 260mm across, 500mm high, has a horizontal extent of 330mm, a downwards extent of 410mm and extends upwards to beyond 600mm. Differences in tone when the trunk is tapped with an acoustic hammer confirm the internal defects and suggest that the column of hollowness extends further up the trunk up to at least 4m from ground level.

7.1.1. I recommend that the four specimens (tree nos. 11, 18, 26 & 55) that are at high risk of collapse are removed. The three planes nos. 11, 18 and 26 are covered by the TPO and therefore will need a tree work application; felling of the Horse chestnut no 55 will need prior notification being made to the LPA six weeks before the works can be undertaken.

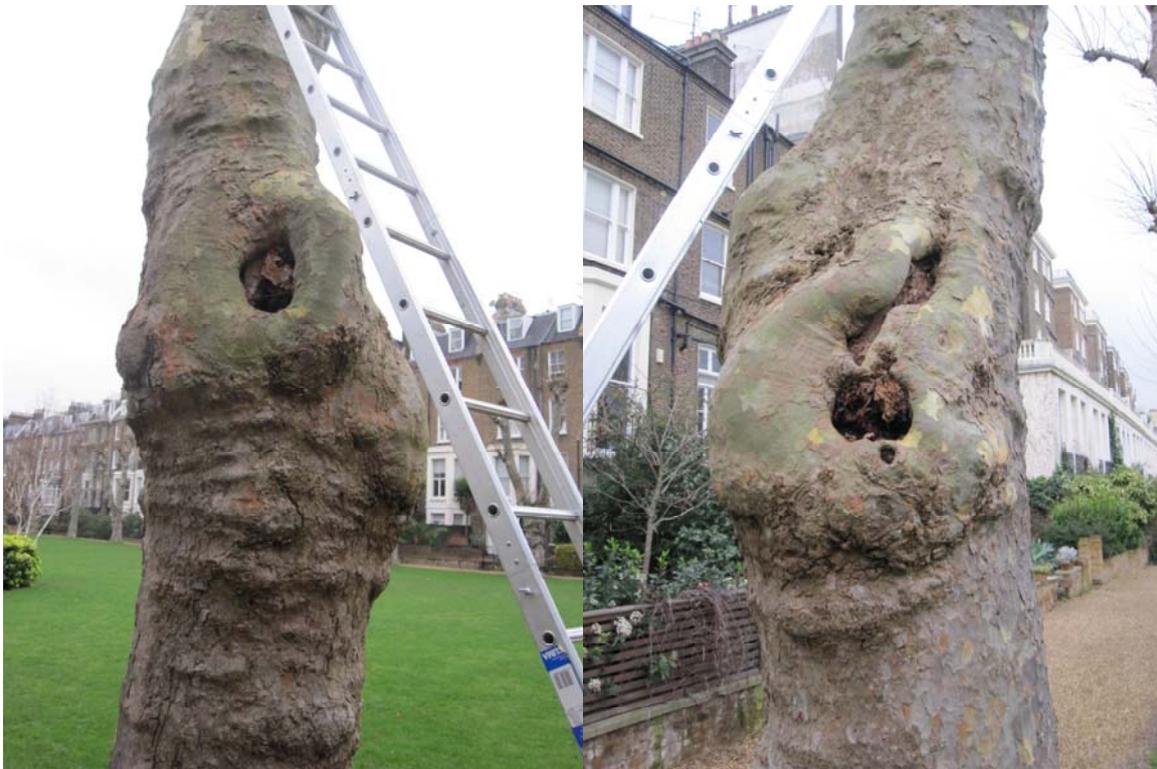
***Photos 2 & 3. Tree no. 18***

5.2.5. Tree no. 18 has a fissure on its east side between two buttress roots (with a horizontal extent of 160mm). Differences in tone when the trunk is tapped with an acoustic mallet suggest internal defects from between 1.75m to 2.5m. There are also two significant cavities, the first is at 2m from ground level (which measures 160mm across, 500mm high, a horizontal extent of 100mm and a downwards extent of 100mm), the second is at 3m from ground level (and measures 150mm across, 200mm high, has a horizontal depth of 300mm and a 45° downwards extent of 510mm).

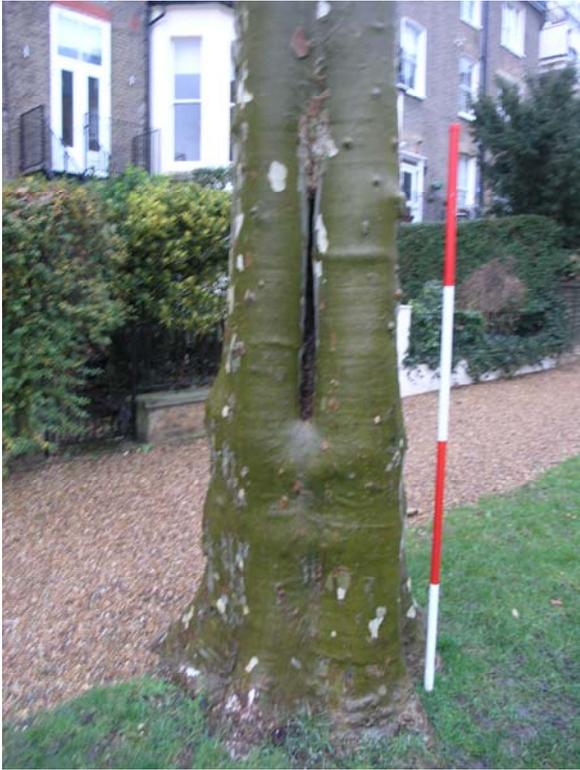
***Photo 4. Tree no. 26***

5.2.6. Tree no. 26 has a significant cavity on its south side that measures 200mm across, 260mm in high, 280mm inwards, an upwards extent of 300mm, and a downwards extent of 370mm. This cavity has significantly decayed wood and hollowness within. Significant changes in tone when the trunk is tapped with an acoustic mallet up to 2m in height confirm the extent of the internal defect. The tree should be removed for sound arboricultural management reasons.
